BELZONA ENGINE BLOCK REPAIR AND PROTECTION

ID: 572

Customer Location: *Iron and steel manufacturing factory,
Egypt*

Application: *ENC-Engines and Casings*

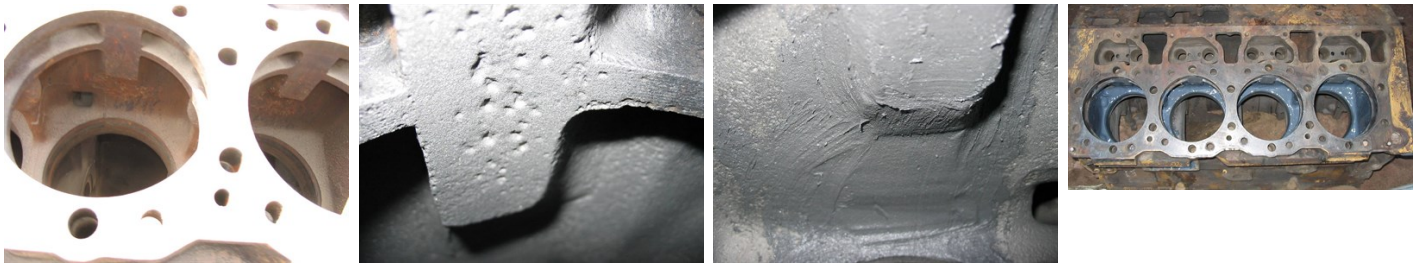
Cavitation and corrosion in water passages of engine block.

- * General view of the block ,
- * Cavitation area after blasting ,
- * Rebuilding cavitation area using Belzona® 1311 (Ceramic R-Metal) ,
- * Applying Belzona® 1391 (Ceramic-HT) to the block ,

Application was carried out in accordance with Belzona Know-How System Leaflet ENC-6.
