Belzona Tail Shaft Repairs

ID: 574

Industry: *Marine*
Application: *SOS-Ships and Offshore Structures*

Ships tailshafts (three)

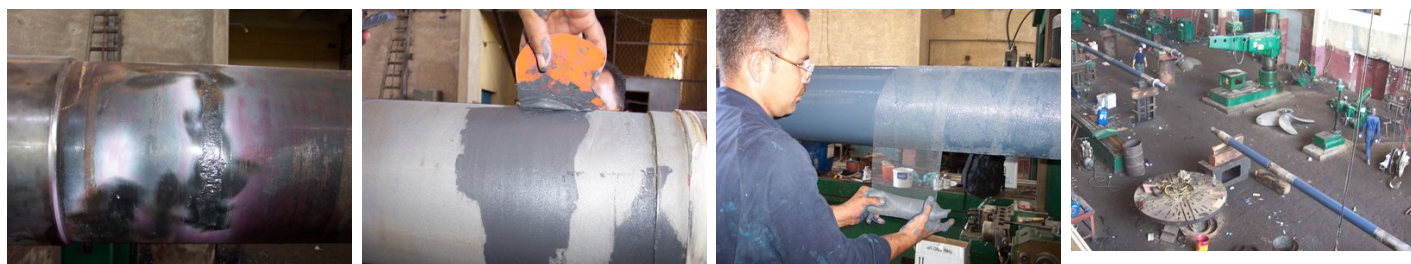
Photograph Descriptions

Corrosion due to failure of fiber glass wrapping.

- * Corrosion pitting shown. ,
- * Rebuilding the corroded areas. ,
- * Applying Belzona® Reinforcement Tape between the first and second layers of Belzona® 1321. ,
- * Three tailshafts were repaired and protected. ,

Application was carried out in accordance with Belzona® Know-How System Leaflet SOS-6.

Belzona repaired the corroded tail shafts, returning them back to dimension without machining. Belzona® 1321 is a corrosion resistant coating and is the best choice for long-term protection to this type of equipment.
