Make Hay While the Sun Shines

ID: 576

Industry: General Industry
Application: MPT-Mechanical Power Transmission

Damaged obsolete U.S. Royal 5.50-16 implement tread tire from J.I. Case 140w hay baler.

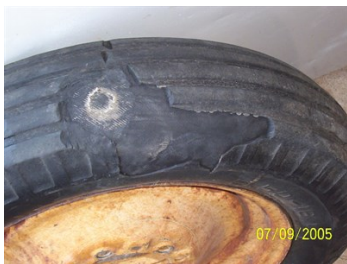
Tire was damaged but cords still in good condition. No replacement available.

- * Damaged tire. ,
- * All loose rubber removed from tire. ,
- * Release agent was applied to a mold. Belzona® 2211 was applied to the tire and mold. ,
- * The tire repaired. ,

Application was carried out in accordance with a modified version of Belzona® Know-How System Leaflet MPT-10.
