# BELZONA GIVES NEW LIFE TO GROCERY STORE FLOOR

ID: 5772

**Customer Location:** Grocery Store, Northern Texas, USA  
**Application Date:** 2014

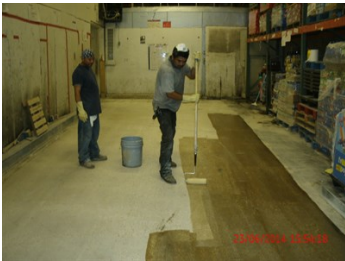
- \* Preparation completed and conditioned with Belzona 4911 ,
- \* Mixing station ,
- \* Application in progress ,
- \* Completed application ,

The floor was ground and conditioned with Belzona 4911 to prepare the surface for application. Then, 1/4 of Belzona 4111 was applied to level the floor.
