BELZONA GIVES NEW LIFE TO GROCERY STORE FLOOR

ID: 5772

Customer Location: Grocery Store, Northern Texas, USA
Application Date: 2014

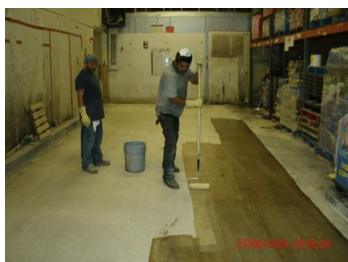
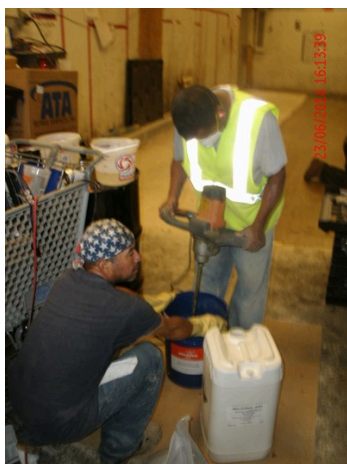
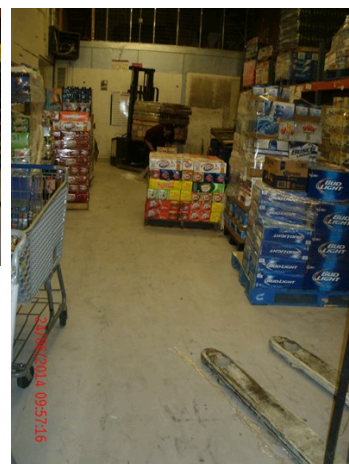
Receiving floor at a grocery store was so rough that groceries were falling off the pallets.

- * Preparation completed and conditioned with Belzona 4911 ,
- * Mixing station ,
- * Application in progress ,
- * Completed application ,

Damaged floor

The floor was ground and conditioned with Belzona 4911 to prepare the surface for application. Then, 1/4 of Belzona 4111 was applied to level the floor.

The application was started in the evening and ready for service by the first delivery. A previous product had failed within months.
