# LEAKING VENT SEALED WITH BELZONA

ID: 5773

Application: *RPA-Roof Problem Areas*

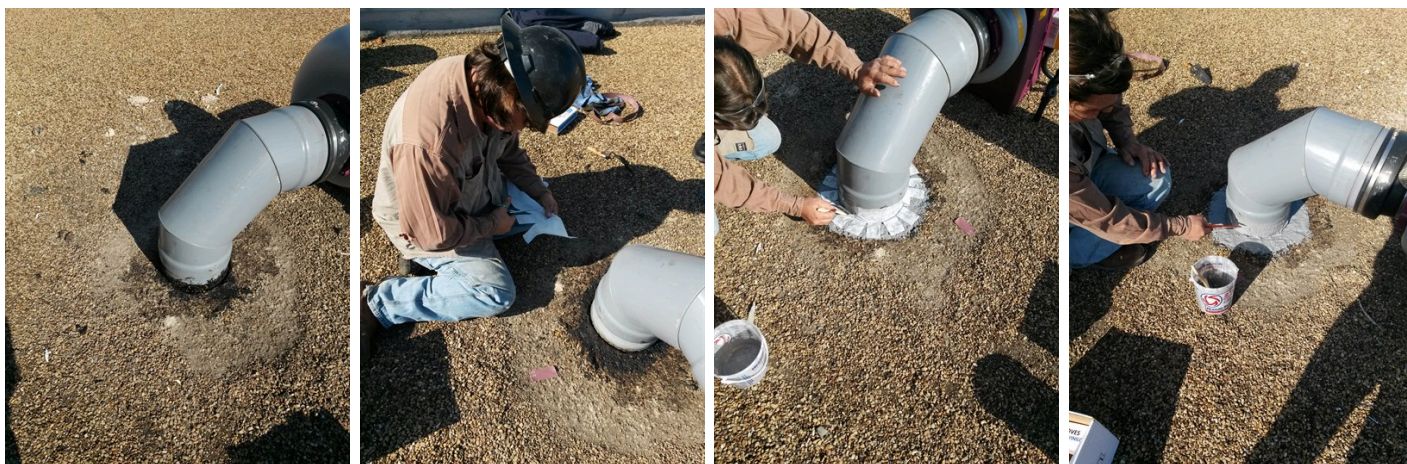
*A roof vent was installed, but ponding water leaked through the black mastic roof sealer.*

- \* Newly installed vent ,
- \* Prepared area ,
- \* Fabric being applied ,
- \* Completed application ,

The application was carried out in accordance with Belzona Know-How System Leaflet RPA-1. The surface was prepared by scraping away the gravel. Then, Belzona 3121 was applied with fabric to seal the duct.

The roof was leaking in the production area from the vent. It was sealed the day before it rained, saving a production shutdown.
