# BELZONA REBUILDS OVERSIZED HOUSING

ID: 5774

Industry: *Marine*  
Application: *SOS-Ships and Offshore Structures*

Customer Location: *Dockyard, Croatia*  
Application Date: *November, 2015*

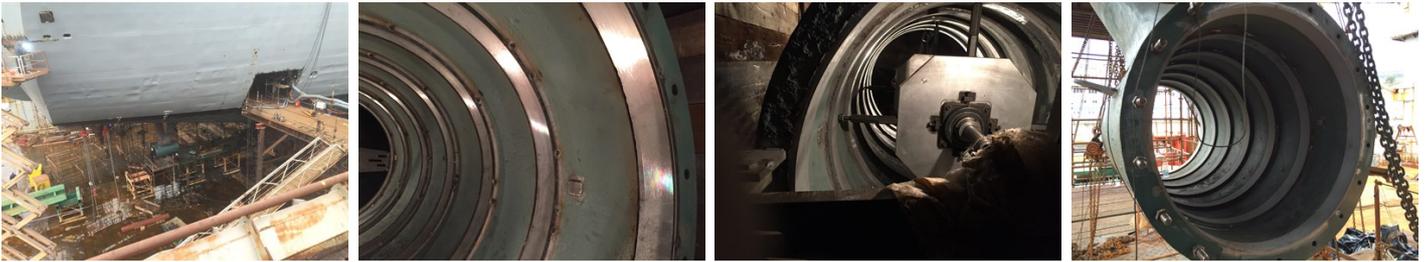
## Photograph Descriptions

*Support surface for bearing sleeves of tail shaft were oversized due to erosion and corrosion.*

- \* General view of ship in drydock ,
- \* Prepared surfaces ,
- \* Machining down to profile ,
- \* Completed application ,

The application was carried out using a modified Belzona Know-How System Leaflet SOS-9. The surfaces were rebuilt then machined to size.
