# HOTEL HOT WATER TANK RESCUE WITH BELZONA

ID: 5780

Potable hot water tank at a large hotel.

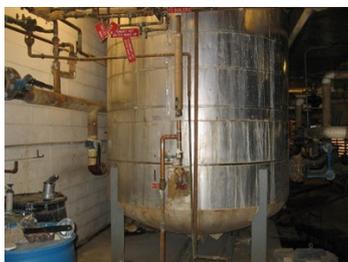
*The hot water tank had been built into the mechanical room in a way that it was impossible to remove and replace it without resituating the whole set up of the room. It had sufficient damage on the interior due to corrosion and buildup of minerals and sediment over the years.*

- \* Hot water tank in the back corner of the mechanical room ,
- \* Interior of the tank showing the corrosion and buildup of sediment ,
- \* Interior repaired and ready for coating ,
- \* Tank repaired and coated, looking like new! ,

The application was carried out in accordance with Belzona Know-How System Leaflet TCC-5. The substrate was first cleaned of loose debris with a chipping hammer then sandblasted to near white metal SSPC-10. It was tested for chlorides. All pitting and weld seams were filled with Belzona 1111, which accounted for about 90% of the substrate surface. Then it was coated with a dual coat system of Belzona 5891.
