BELZONA REBUILDS OVERSIZE KEYWAY

ID: 580

Shaft from double suction split case centrifugal pump.

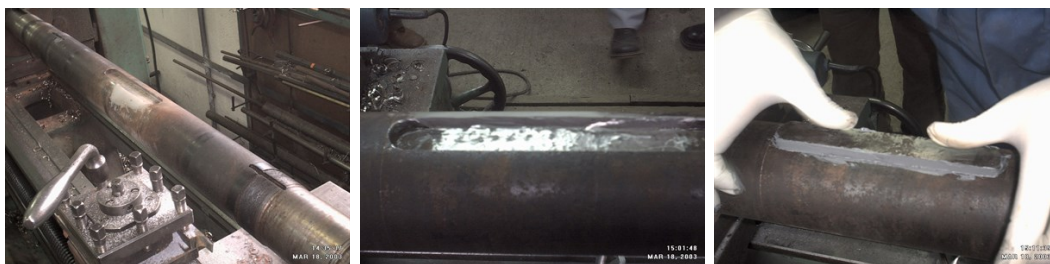
Photograph Descriptions

Broken edge of the keyway seat. Insufficient contact area for the load transmission.

* The worn keyway Surface prepared Keyway being bedded into Belzona ,

The application was carried out in accordance with Belzona Know-How System Leaflet MPT-4.

Belzona repair provided a low cost alternative to welding and re-machining with a fast return to service. The repair was still in service when checked (June 2007).
