BELZONA REBUILDS OVERSIZE KEYWAY

ID: 580

Industry: Water / Wastewater

Customer Location: Water supply company, Bulgaria

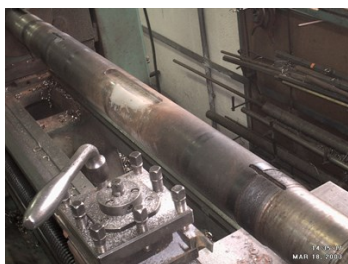
Broken edge of the keyway seat. Insufficient contact area for the load transmission.

* The worn keyway Surface prepared Keyway being bedded into Belzona ,
