# END COVER OF CONDENSER RECEIVES BELZONA HT SOLUTION

ID: 5806

**Customer Location:** Gas Plant, Southeast China  
**Application Date:** August 2010

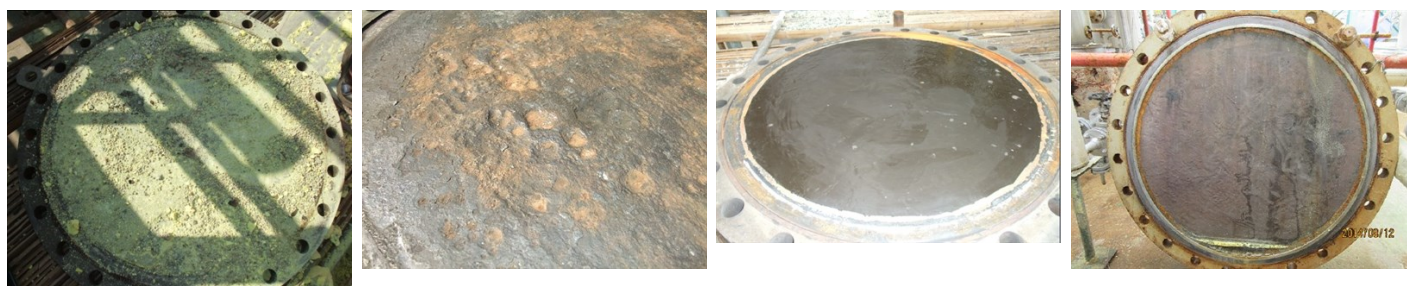
Severe pitting corrosion appeared on the cover after years of operation. The worst pitting is about 10mm deep.

- \* The internal surface before application ,
- \* Severe pitting damage ,
- \* Completed application ,
- \* The coating after 4 years shows no sign of further corrosion ,

Application was carried out in accordance with Belzona Know-How System Leaflet HEX-3. Belzona 1511 was used to rebuild the profile followed by an application of Belzona 1591 as a high temperature protective coating.

The cover was originally unlined. Belzona's solution prevented the cover from further corrosion, extended the equipment life and eliminated the cost of replacement. After 4 years in service, the coating is in perfect condition.
