# BELZONA REPAIRS AND PROTECTS CHILLER UNITS FROM CORROSION

ID: 5808

Industry: Heating, Ventilation & Air Conditioning

Application: TCC-Tanks and Chemical Containment Areas

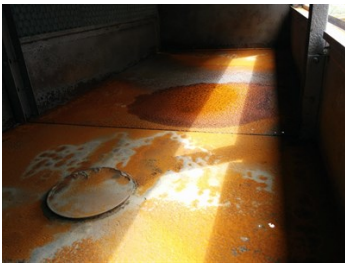
The holding pans in the chiller units had corroded and required immediate attention.

- \* Prior to application ,
- \* Preparation in progress ,
- \* First coat of Belzona 5811 ,
- \* Completed application ,

The application was carried out in accordance with Belzona Know-How System Leaflet TCC-15 for sealing and protecting containment areas. To prepare the holding pans, a grit blaster was used to remove the corrosion. Belzona 1111 was used to plate bond patched and to seal all edges and joints. Two coats of Belzona 5811 were applied to the units in accordance with Belzona Instructions For Use.
