BELZONA REPAIRS AND PROTECTS CHILLER UNITS FROM CORROSION

ID: 5808

Holding Pans in chiller units.

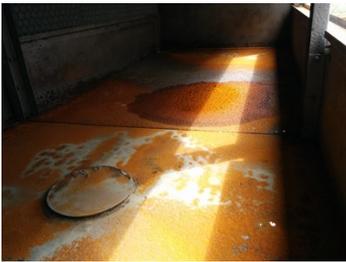
The holding pans in the chiller units had corroded and required immediate attention.

- * Prior to application ,
- * Preparation in progress ,
- * First coat of Belzona 5811 ,
- * Completed application ,
