BELZONA REPAIRS AND PROTECTS CHILLER UNITS FROM CORROSION

ID: 5808

Holding Pans in chiller units.

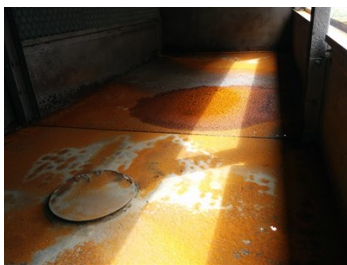
The holding pans in the chiller units had corroded and required immediate attention.

- * Prior to application ,
- * Preparation in progress ,
- * First coat of Belzona 5811 ,
- * Completed application ,

The application was carried out in accordance with Belzona Know-How System Leaflet TCC-15 for sealing and protecting containment areas. To prepare the holding pans, a grit blaster was used to remove the corrosion. Belzona 1111 was used to plate bond patched and to seal all edges and joints. Two coats of Belzona 5811 were applied to the units in accordance with Belzona Instructions For Use.
