BELZONA STOPS TANK LEAK

ID: 5809

Customer Location: Power Plant, Northern Texas, USA
Application Date: 2014

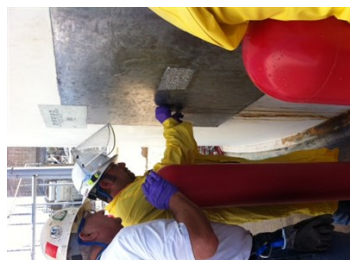
Emergency water tank was thin walled and leaking. Welding produced more leaks. The tank could not be taken out of service. Thin wall and leaks needed to be fixed while the tank was full.

- * Area to be repaired ,
- * Stopping leaks ,
- * Applying Belzona 1111 ,
- * Completed repair ,
