# BELZONA REPAIRS CLARIFIER WITH 2" GOUGE

ID: 5816

Clarifier in a Waste Water Treatment Plant

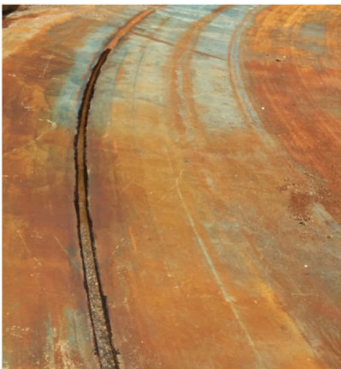
The sweeper arm in the clarifier had sagged over the year's and had worn a 2 inch gouge around the diameter of the tank.

- \* Prior to application ,
- \* Application in progress ,
- \* Completed application ,
