# BELZONA REPAIRS CLARIFIER WITH 2" GOUGE

ID: 5816

Industry: Water / Wastewater  
Application: FPA-Floor Problem Areas  
Substrate: Steel  
Products: \* Belzona 4131 (Magma-Screed) ,  
\* Belzona 4911 (Magma TX Conditioner) ,

Customer Location: Niagara Region, ON, Canada  
Application Date: July 2015

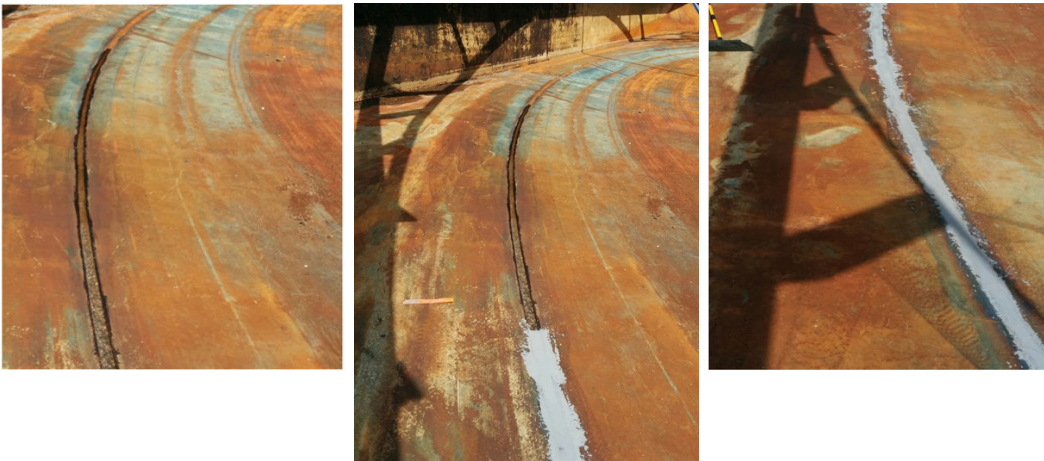
The sweeper arm in the clarifier had sagged over the year's and had worn a 2 inch gouge around the diameter of the tank.

- \* Prior to application ,
- \* Application in progress ,
- \* Completed application ,

The application was carried out in accordance with Belzona Know-How System Leaflet FPA-1 for rebuilding worn and damaged floor surfaces. The damaged area was manually prepared to remove any scale and debris. Belzona 4911 was applied to the surface using a bristle brush and Belzona 4131 was applied to the damaged area in accordance with Belzona Instructions For Use.

Belzona 4131 has a high performance non-porous resurfacing material that provides excellent protection against the effects of abrasion, impact, vibration, chemical attack, outstanding environmental protection and is impermeable to water. The clarifier was ready for service within a few days.
