BELZONA OFFERS PROTECTION TO METAL WEAR PLATES

ID: 5818

Metal wear plates in a blast machine.

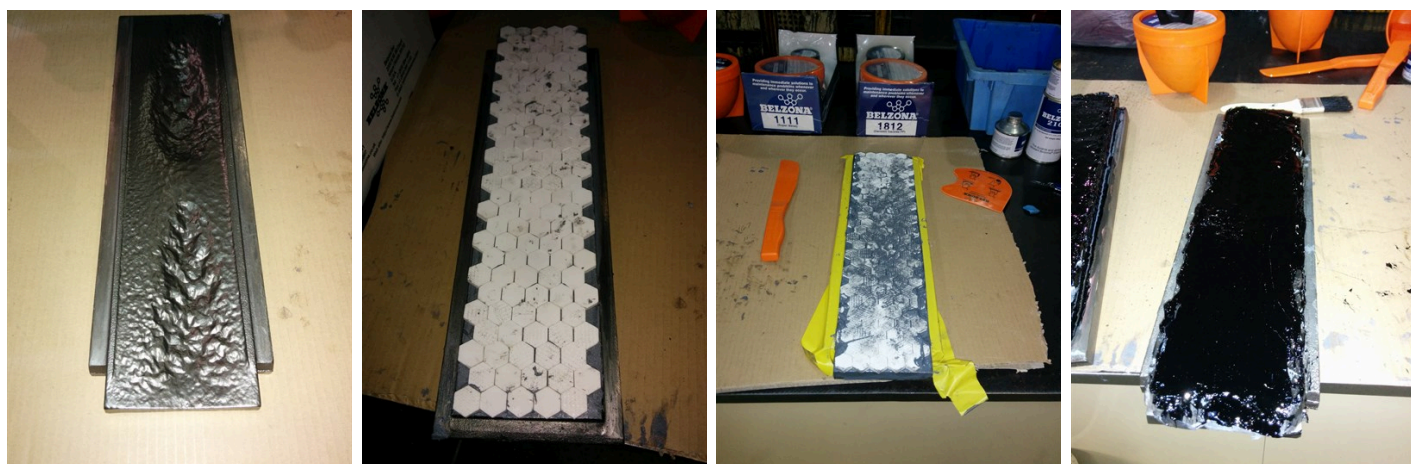
Photograph Descriptions

The wear plates were constantly eroded by the blast media and only lasted weeks in service before being replaced. A big problem arose when the replacement plates became delayed in production and therefore unavailable.

- * Prior to application ,
- * Preparation in progress ,
- * Preparation in progress ,
- * Completed application ,

The application was carried out in accordance with Belzona Know-How System Leaflet SHM-7 for bonding and grouting tiles and wear plates. Belzona 1111 was used to rebuild the worn areas and to bond Belzona 9811 as soon as the worn areas were filled.

Belzona 9811 was removed from the sheet and placed tightly together to eliminate grouting. The plates were then coated with Belzona 2111 for added protection from the impact of the blast material.
