# BELZONA RESTORES RISER OF OIL & GAS PRODUCTION PLATFORM

ID: 5823

4" diameter riser on oil & gas production platform.

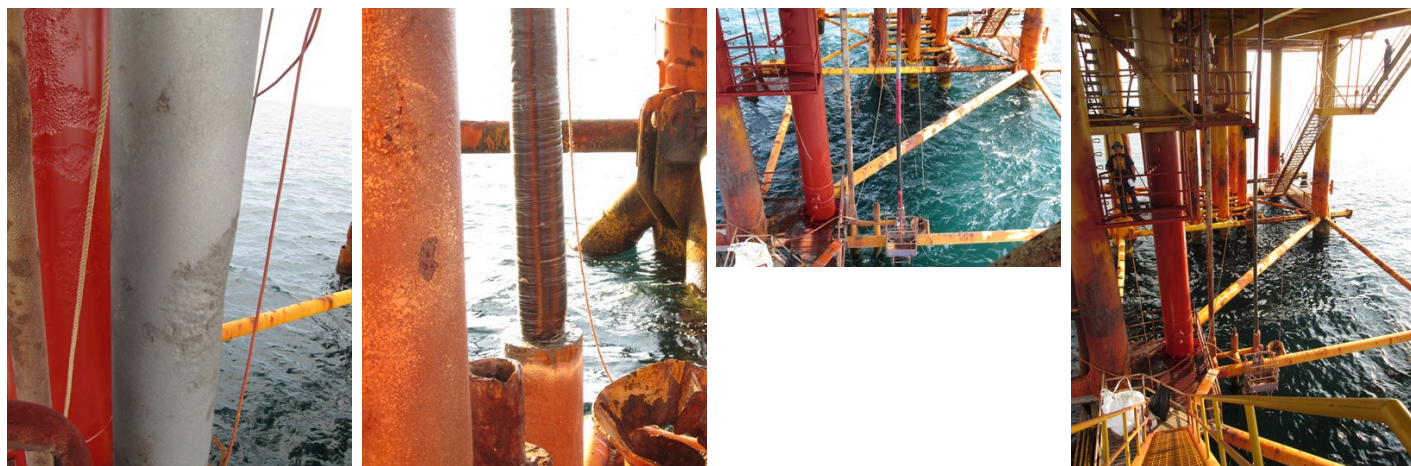
Riser suffering from corrosion due to the offshore environment required the restoration of metal loss and protection from further deterioration. The asset owner was interested in a compliant composite solution. A metallurgy survey determined there were three sections of the riser that required the installation of SuperWrap II.

- \* Condition of riser after abrasive blasting. ,
- \* Belzona 1982 applied in 5 wraps (10 layers). ,
- \* Belzona 9382 installed to consolidate the repair. ,
- \* Completed application - overall view of the three riser sections installed. ,

The area to be repaired was grit blasted to produce SSPC-SP 10 (Near White) with a minimum anchor profile of 3 mils. Belzona 9111 was used to clean and degrease the blasted surface. Belzona 1121 was used to fill pitted areas and restore original wall thickness. Belzona 9381 was saturated with Belzona 1982 and applied onto the riser in 5 wraps (10 layers) in compliance with the engineered design. Belzona 9382 was used to consolidate the repair and removed after the 24 hour curing process.
