BELZONA PROTECTS HELLAN FLUID STRAINER FROM WASTE

Industry: Water / Wastewater
Application: CEP-Centrifugal Pumps
Substrate: Steel
Products: * Belzona 1212 ,
* Belzona 1331 ,

Customer Location: Pickering, ON, Canada
Application Date: June 2015

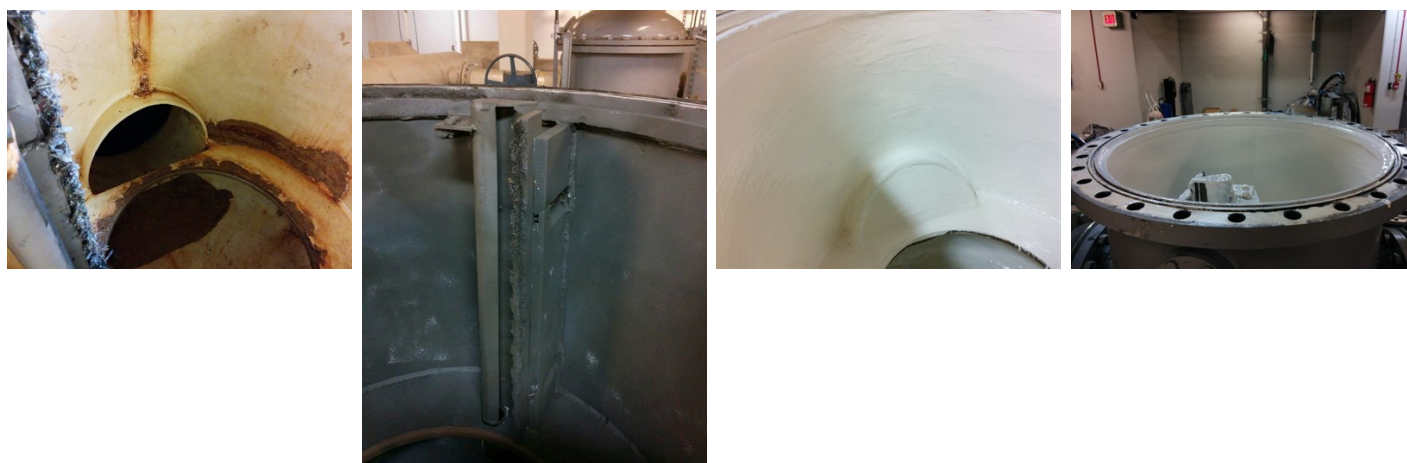
Photograph Descriptions

Erosion/Corrosion from the waste water.

- * Prior to application ,
- * Preparation of the surface ,
- * Completed application ,
- * Completed application ,

The application was carried out in accordance with Belzona Know-How System Leaflet CEP-5 for the repair of general erosion damage. The surface was blasted to prepare the area. Belzona 1212 was applied to build up any areas that were pitting. As a two coat system, Belzona 1331 was brush applied to the surface in accordance with Belzona Instructions For Use.
