# BELZONA PROTECTS HELLAN FLUID STRAINER FROM WASTE

ID: 5824

A Hellan fluid strainer at a Water Pollution Control Plant.

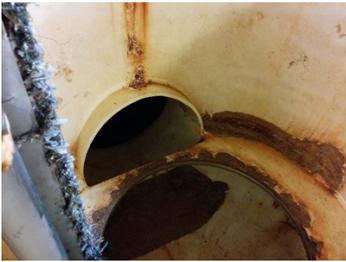
*Erosion/Corrosion from the waste water.*

- \* Prior to application ,
- \* Preparation of the surface ,
- \* Completed application ,
- \* Completed application ,
