BELZONA PROTECTS HELLAN FLUID STRAINER FROM WASTE

ID: 5824

Industry: *Water / Wastewater*
Application: *CEP-Centrifugal Pumps*
Substrate: *Steel*
Products: ** Belzona 1212 ,*
** Belzona 1331 ,*

Customer Location: *Pickering, ON, Canada*
Application Date: *June 2015*

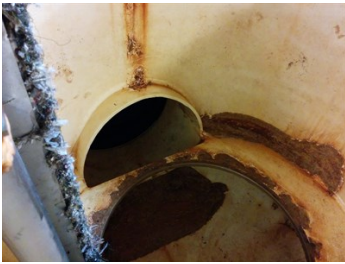
Erosion/Corrosion from the waste water.

- * Prior to application ,
- * Preparation of the surface ,
- * Completed application ,
- * Completed application ,

The application was carried out in accordance with Belzona Know-How System Leaflet CEP-5 for the repair of general erosion damage. The surface was blasted to prepare the area. Belzona 1212 was applied to build up any areas that were pitting. As a two coat system, Belzona 1331 was brush applied to the surface in accordance with Belzona Instructions For Use.
