BELZONA RESTORES WEMCO FLOTATION CELL

ID: 5825

Customer Location: Gulf of Mexico, USA

Application Date: October 2014

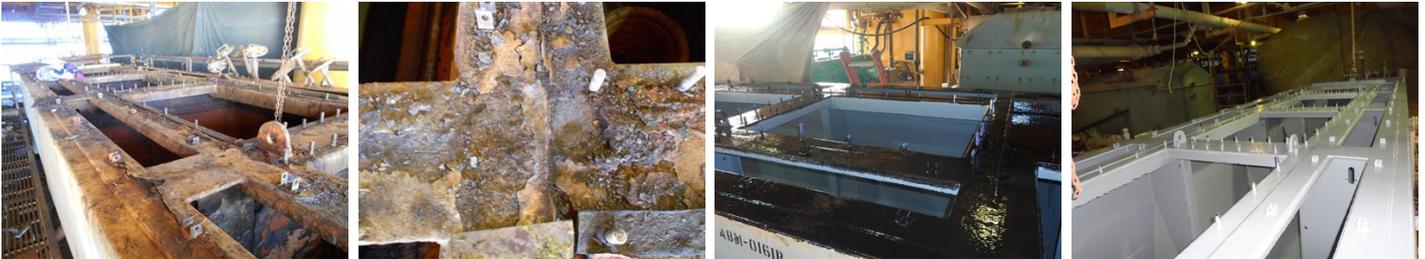
Severe corrosion of internals/externals causing through/thin wall defects and loss of containment. Besides, the hatch covers could not seal properly.

- * View of Wemco unit exterior before the blasting/cleaning. ,
- * Close up view of the metal loss. ,
- * View of restoration in progress after the first coat of Belzona 5811. ,
- * Completed application with a top coat of Belzona 5111. ,

All internal/external surfaces were grit blasted to SP 10 (Near White Metal) with a minimum anchor profile of 3 mils. Belzona 9111 was used to clean and degrease all surfaces. Belzona 1121 was used to repair pitted areas and restore the surface to its original profile. Small hole through defects (2" dia. or less) were repaired by using Belzona 1121/4151/9371 for a composite patch and larger defects were repaired by cold plate bonding using Belzona 1121 to adhere plates. Hatch cover seal areas were restored to the level profile with Belzona 1121 and sanded smooth. A two coat system of Belzona 5811 was applied to all internal/external surfaces

and a top coat of Belzona 5111 was applied to external surfaces.
