# BELZONA RESTORES OFFSHORE CRANE ROOF

ID: 5828

Industry: Oil & Gas  
Application: SOS-Ships and Offshore Structures

Crane roof on offshore production platform.

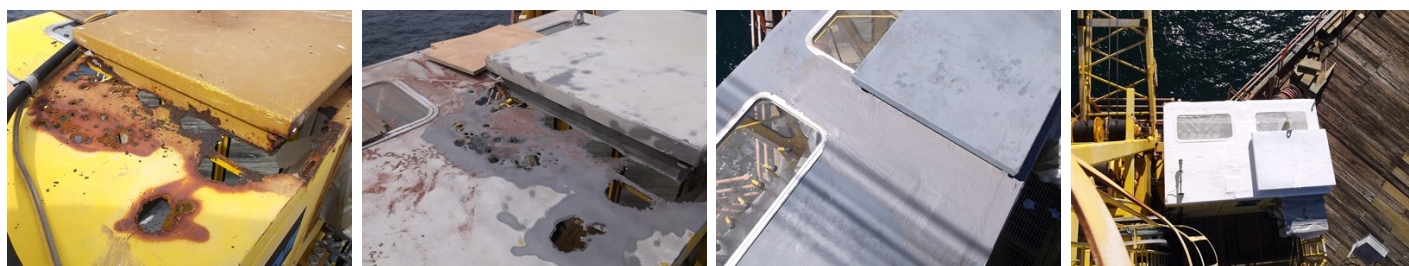
Severe corrosion deteriorated the crane roof, causing hole through/thin wall defects and loss of structural integrity.

- \* Crane roof before restoration. ,
- \* Crane roof after grit blasting. ,
- \* Plate bonding installed using Belzona 1121 to adhere plates. ,
- \* Completed application - fully reinforced two coat system of Belzona 3111/9311. ,

The crane roof was grit blasted to SP 10 with a minimum anchor profile of 3 mils. The repair area was cleaned and degreased with Belzona 9111. All through/thin wall defects were repaired with the Belzona Plate Bonding System using Belzona 1121 to adhere plates. Belzona 3921 was installed by brush and allowed to cure. A two layer system of Belzona 3111 was installed, incorporating Belzona 9311 in the first layer.
