# OFFSHORE PRODUCTION DECK RESTORATION WITH BELZONA

ID: 5829

Industry: Oil & Gas  
Application: SOS-Ships and Offshore Structures

Customer Location: Gulf of Mexico, USA  
Application Date: November 2013

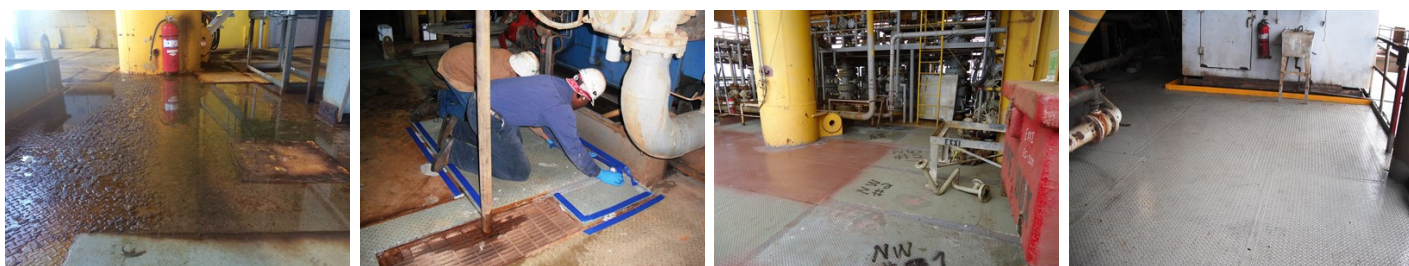
Years of service without adequate maintenance in the offshore environment caused severe corrosion/metal loss of the production deck, impacting the structural integrity and personnel safety.

- \* Condition of deck before restoration. ,
- \* Installation of plate bonding system. ,
- \* Restoration of new plates complete. ,
- \* Two coat system of Belzona 5811 applied to new deck plates. ,

Total restoration of production platform deck using Belzona Cold Plate bonding system.

The deck area to be restored was cleaned and prepared by UHP/aggregate/rust inhibitors. Belzona 9111 was used as a wipe down to clean and degrease all areas. The Belzona Cold Plate Bonding System was installed using Belzona 1121 as adhesive. A two coat system of Belzona 5811/Aggregate was installed afterwards. The aggregate was used to create an antislip surface.
