# BELZON SEALS THE MANWAY FLANGE OF A HEATER TREATER

ID: 5832

**Industry:** Oil & Gas  
**Application:** VPF-Valves, Pipes and Fittings  
**Substrate:** Carbon Steel  
**Products:** \* Belzona 1111 (Super Metal) ,  
\* Belzona 9111 (Cleaner Degreaser) ,  
\* Belzona 9411 (Release Agent) ,

**Customer Location:** Gulf of Mexico  
**Application Date:** March 2015

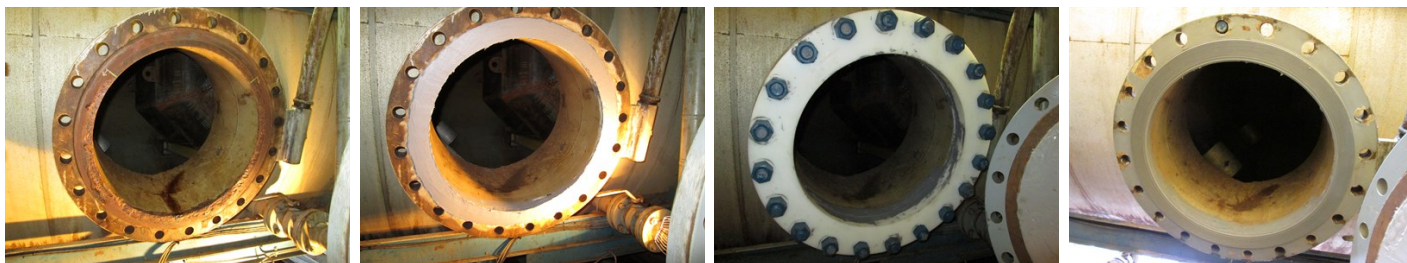
## Photograph Descriptions

After years of service, the manway flange sealing surface was pitted/deteriorated and was not sealing properly. The customer needed a repair system that could restore the sealing surface of the manway flanges without hot work, which would cause unwanted downtime.

- \* View of pitted/damaged flange face. ,
- \* Belzona 1111 applied to receiver flange after grit blasting, and to machined area of template. ,
- \* Template bolted to receiver flange. ,
- \* Application complete - reformed flange face ready for service. ,

The flange face forming repair was conducted in accordance with Belzona Know-How System Leaflet VPF-17. The receiver flange was prepared by grit blasting and a polyurethane template was machined to specifications and coated with Belzona 9411. It was allowed to dry and a layer of Belzona 1111 was installed on the template and receiver flange. Then, the template was bolted to the receiver flange for two hours, allowing Belzona 1111 to cure. The template was then removed and the receiver flange cleaned and dressed.
