BELZONA REPAIRS FLOOR CRACKS CAUSED BY A ZAMBONI

ID: 5837

Customer Location: Kitchener, ON, Canada
Application Date: August 2013

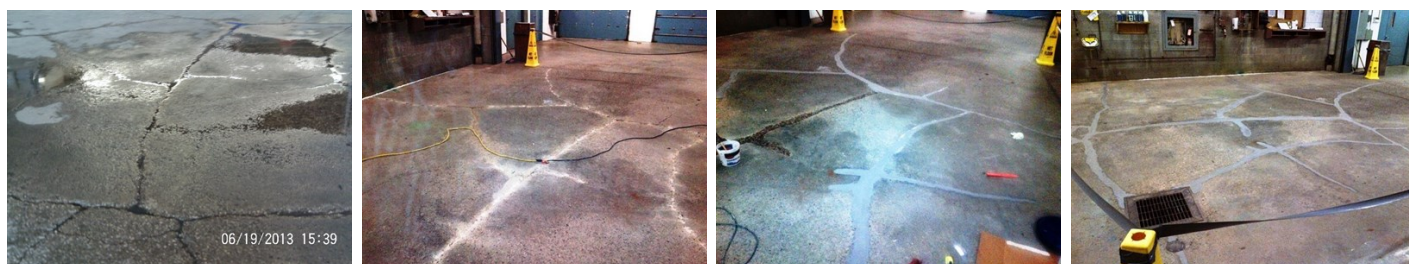
Photograph Descriptions

Cracks and pitting caused by studded tyres of a Zamboni.

- * Prior to application ,
- * Surface preparation in progress ,
- * Application in progress ,
- * Completed application ,

The application was carried out in accordance with Belzona Know-How System Leaflet FPA-1 for rebuilding worn and damaged floor surfaces. The surface was prepared by removing all loose concrete and a high pressure washer was used to remove any contamination. After preparation of the surface, Belzona 4911 was applied to achieve maximum adhesion. Then, Belzona 4131 was applied using a trowel in accordance with the Belzona Instructions For Use.
