BELZONA PROTECTS DOOR TO DIGESTER AGAINST CORROSION

ID: 5838

Customer Location: Niagara Region, ON, Canada
Application Date: December 2014

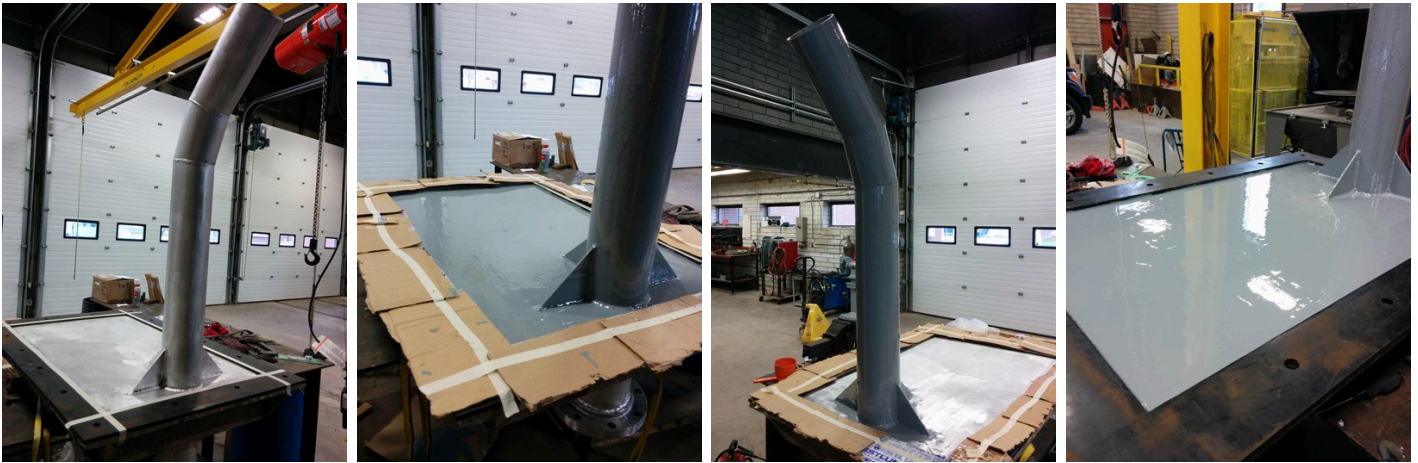
Photograph Descriptions

The previous door was suffering from corrosion. The customer wanted long-term protection on the new door prior to installation.

- * Prior to application ,
- * Application in progress ,
- * Application in progress ,
- * Completed application ,

The application was carried out in accordance with Belzona Know-How System Leaflet VPF-2 for applying erosion-corrosion resistant coatings. A grit blaster was used to prepare the surface. Belzona 5811 was applied as a two coat system using a short bristle brush in accordance with the Belzona Instructions For Use.
