# BELZONA PREVENTS CORROSION DAMAGE TO 18' RISER

ID: 5840

Industry: Oil & Gas  
Application: SOS-Ships and Offshore Structures

Customer Location: Texas, USA  
Application Date: August 2015

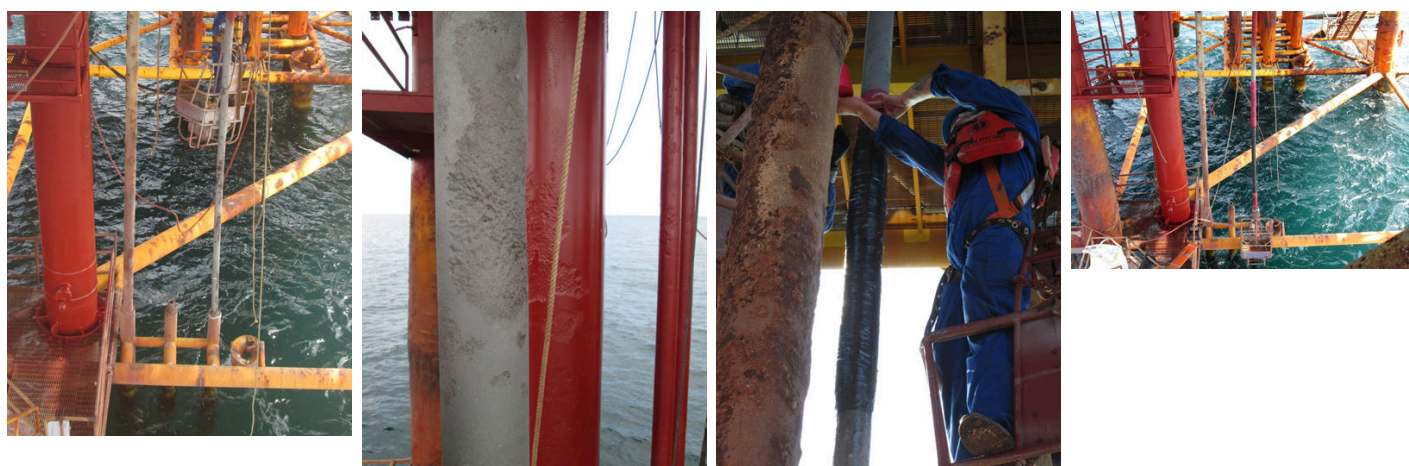
Corrosion damage to riser.

- \* View of 18' riser prior to repair ,
- \* Surface preparation ,
- \* Application of Belzona 1982 complete ,
- \* View of repair with Belzona 9382 wrapped over SuperWrap II during cure ,

The surface was blasted to the requirements of SSPC SP10 (Near White Metal). Profile measurements were checked and the surface

was cleaned and degreased with Belzona 9111. Belzona 1121 was then applied to 18' of the riser to fill pitting in order to restore the original pipe thickness. Belzona 1121 was sanded to abrade the surface and wiped down with Belzona 9111. Belzona 1982 was applied in 5 layers. Belzona 9382 was wrapped over the Superwrap II application area to consolidate and compress during cure.
