BELZONA PROVES TO BE THE RIGHT CHOICE FOR FLANGE PROTECTION

ID: 5841

Industry: Oil & Gas
Application: GSS-Gaskets, Seals and Shims
Substrate: Carbon Steel
Products: * Belzona 3411 (Encapsulating Membrane) ,
* Belzona 8411 ,

Customer Location: Texas, USA
Application Date: December 2014

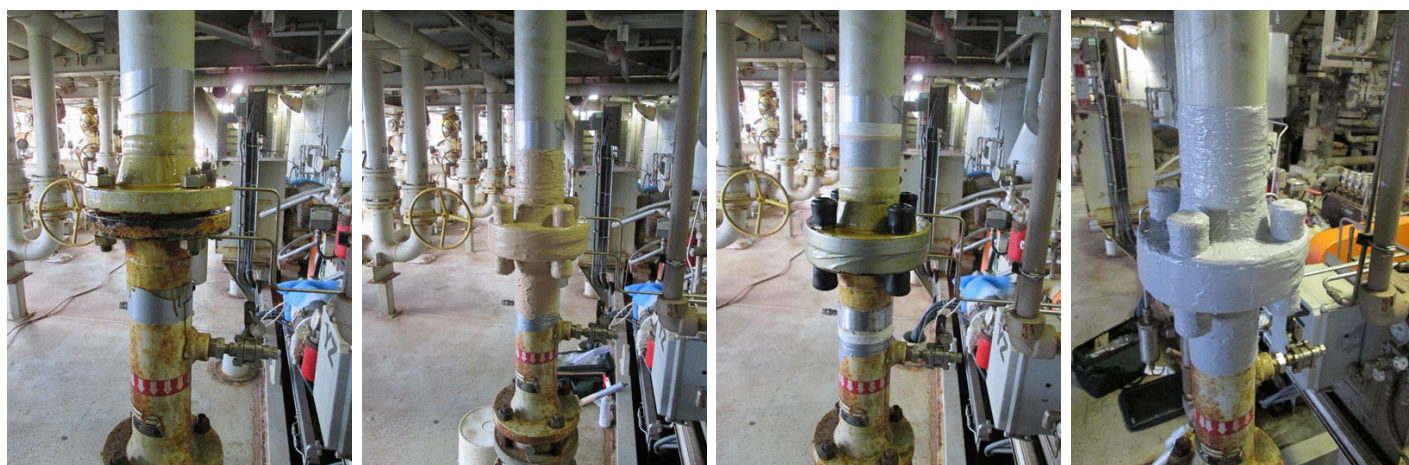
Photograph Descriptions

Corrosion around the flanges and bolts resulted in serious damage. The customer was looking for a practical and efficient solution to this problem. Several manufacturers were considered for the task including Belzona. Application was to be completed in situ and inspected after 6 months.

- * After surface preparation, Belzona 8411 was applied to the flange ,
- * Substrate ready for application with bolt covers and bridging tape ,
- * Application of base coat of Belzona 3411 ,
- * Application completed with second coat of Belzona 3411 ,

Flange on an offshore platform.

The application was carried out in accordance with Belzona Know-How System Leaflet GSS-11.

The customer chose Belzona since a competitor's solution 'oozed' out some sort of embedded corrosion inhibitor that looked like leaking oil. After a 6 month trial inspection, the Belzona coating was removed and the underlying flange was visually evaluated. The Customer was pleased with the results and decided to install the Belzona 3411 system on other facilities.
