# BELZONA 1291/1212 REPAIRS PUMP UNDER PRESSURE

ID: 5843

Customer Location: Power Plant, Missouri, USA  
Application Date: Late Summer 2015

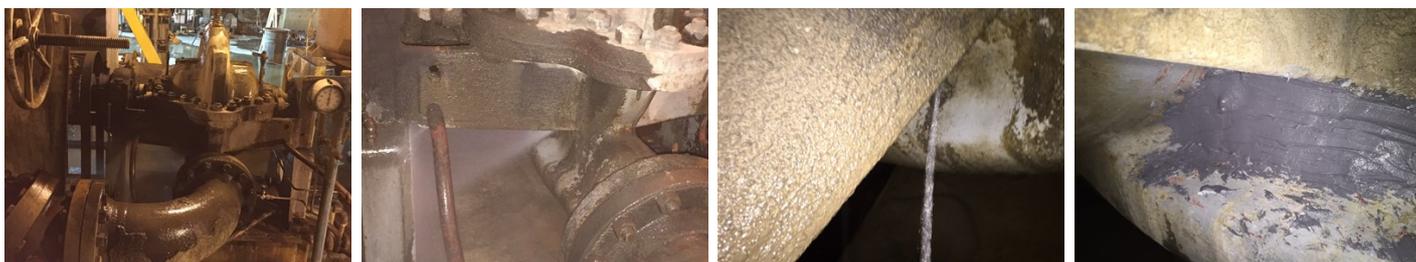
- \* View of pump operating at 200 psi visible on the gauge. ,
- \* Actual leak. ,
- \* Valves were shut off and leak was slowed down to complete the repair. ,
- \* Completed repair and in service with Belzona 1291 and Belzona 1212. The pump was slowly brought back up to full pressure to assure the leak was fixed. ,

The customer had a 200 psi high pressure raw water pump casing that was leaking. This pump could only be out of service for a small amount of time.

The surface preparation was carried out with a scraper to remove the layers of paint. Then, a coarse file was used to etch around the hole and an MBX bristle blaster was used to prepare the surface. Bonding a plate was not an option due to the location of the hole being below where the casing was bolted together. Belzona 1291 was used to stop the active leak and Belzona 1212 was used to add thickness back to the pump casing that was saturated with water.

The pump could not be out of service for a long amount of time as this is the power plant's peak season. Replacement of the pump would have taken a week. This repair was done in an hour and the pump was put back in service with the leak completely sealed. Belzona has sealed many active leaks at this power plant and due to a previous leak repair that has been in service for 5 years, Belzona was called once again for this emergency.
