BELZONA REPAIRS FLANGE OF OFFSHORE PLATFORM

ID: 5845

Customer Location: Gulf of Mexico, USA
Application Date: August 2015

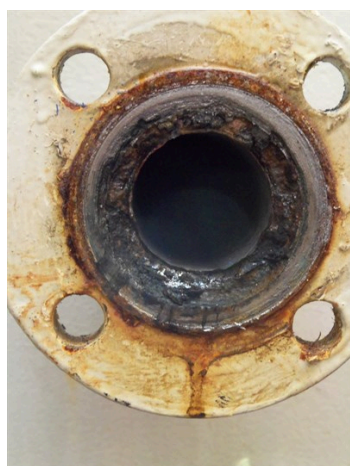
- * Original condition ,
- * Ready for bolting together ,
- * Flange former in place ,
- * Completed application ,

An offshore platform was experiencing a leak in a nozzle flanged connection on a Deaerator Tower. The corrosion was related to high concentration of an oxygen scavenger chemical.
