BELZONA REPAIRS CORRODED PIPEWORK ON METHANE TANK

Customer Location: Water treatment plant, Bulgaria

Application Date: July 2004

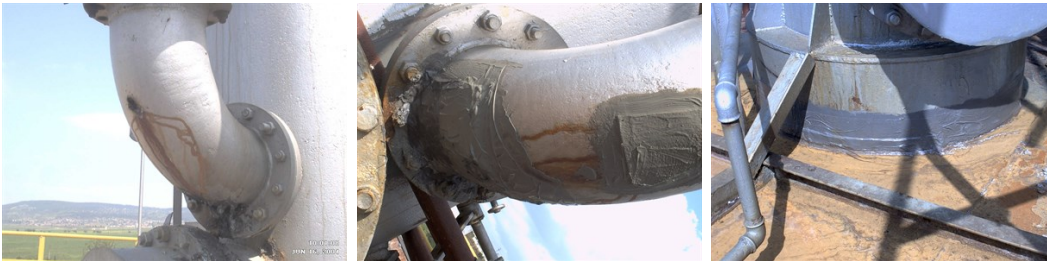
Corroded area and leaking hole on the Methane pipework.

- * Damaged areas preview ,
- * Belzona® 4301 applied with reinforcement plates ,
- * Belzona® 3121 applied over the corroded areas ,

Application was carried out in accordance with Belzona System Leaflet VPF-11a. Belzona® 4301 was applied with reinforcement plates over the holed areas. Further Belzona® 3121 with Reinforcing Sheet was applied over the severely corroded areas for protection and to prevent gas leakage.
