BELZONA REPAIR TO KING PIN BUSH HOUSING

ID: 588

Front end loader king pin connection

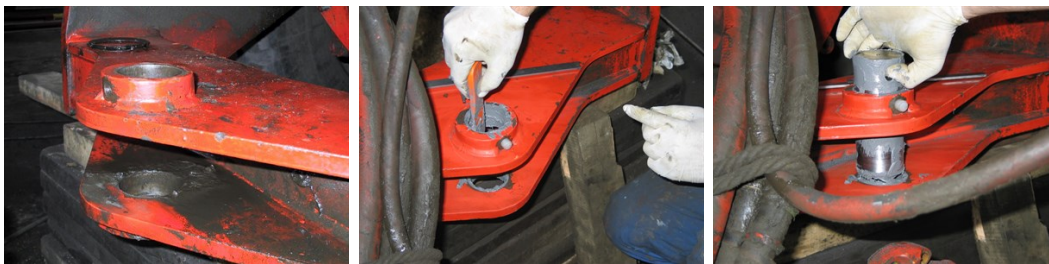
Photograph Descriptions

Wear of the seats leading to increased clearance

* View of the damaged connection. , * Belzona® 1111 applied on the prepared housing surface. , * The pin coated with release agent was used to form the housing. ,

Application was carried out in accordance with Belzona Know-How System Leaflet MPT-8.

Belzona returned the equipment to service in one day. The Belzona repair was simple to carry out and saved machining.
