BELZONA SEALS VALLEY GUTTERS

ID: 5887

Customer Location: *Manufacturing Plant, Scotland*
Application Date: *October 2014*

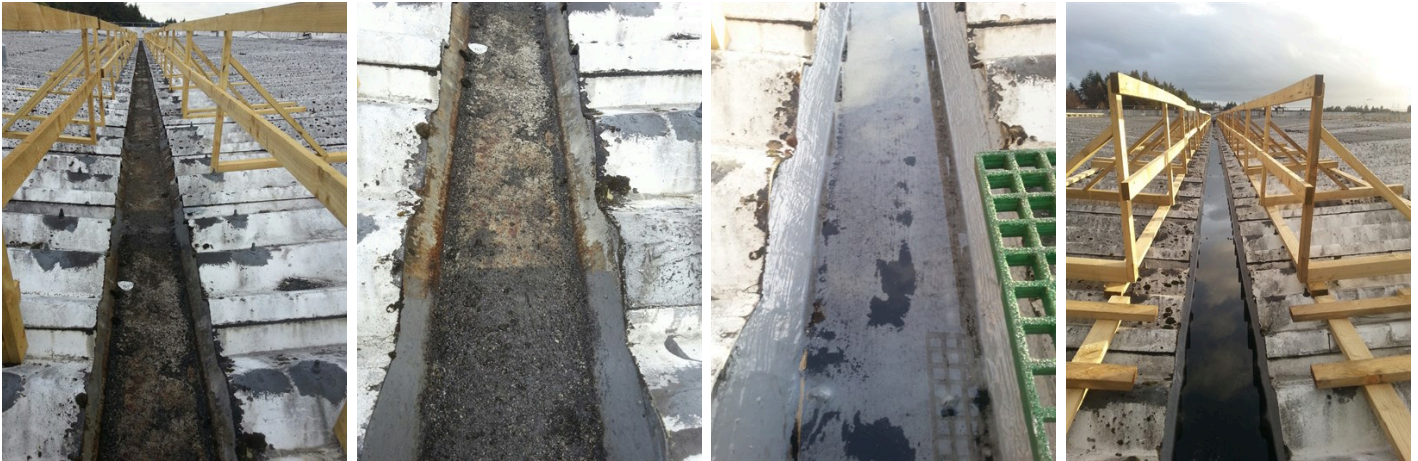
Photograph Descriptions

- * Length of gutters before surface preparation ,
- * Section of gutter showing build up of dirt & corrosion ,
- * Length of gutter coated ,
- * Standing water still an issue but the gutter is now leak free ,

Several valley gutters constructed from cast steel had begun to leak from the joints. These leaks were causing damage to the stored materials below.

The application was carried out in accordance with Belzona Know-How System Leaflet RPA-6.

Belzona 3131, a liquid applied membrane, allowed the applicators to coat the existing substrate without removing large sections of

the roof. The Belzona 3131 system is flexible, which has allowed a long lasting repair over the problem joints where competitor materials had failed.
