TIRE REPAIR WITH BELZONA ELASTOMER

ID: 589

Rear tire of front end loader.

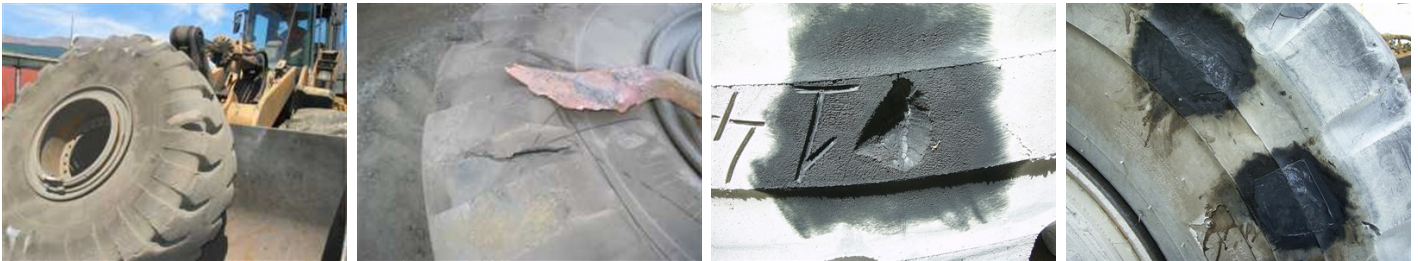
Photograph Descriptions

A piece of metal penetrated the sidewall.

- * Size of the tire clearly evident ,
- * The metal alongside and the damage it caused ,
- * Prepared and conditioned area ,
- * Finished Elastomer repair ,

Application was carried out in accordance with a modified version of Belzona Know-How System Leaflet SHM-1.

The client insisted on repairing this tire based on his good experience with Belzona solutions and the alternative expensive replacement. The tire was in service nearly one year following the repair.
