# SHAFT JOURNAL OF STONE CRUSHER REPAIRED WITH BELZONA

Industry: *Chemical & Petrochemical*  
Application: *MPT-Mechanical Power Transmission*

Customer Location: *Chemical industry, Bulgaria*  
Application Date: *July 2002*

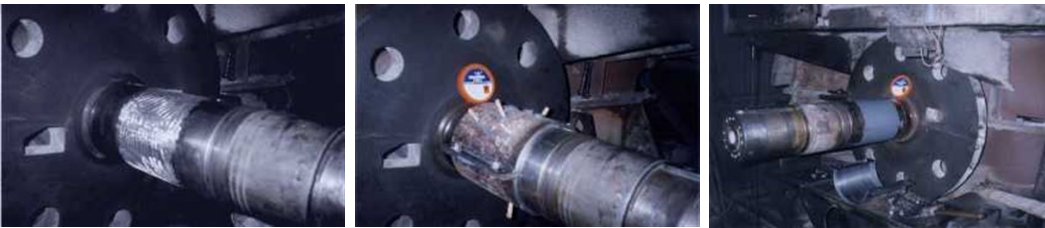
## Photograph Descriptions

*Shaft damaged by seized bearing.*

- \* Preparing shaft surface ,
- \* Forming with manufactured pipe clamp ,
- \* View of repair with former removed ,

Application was carried out in accordance with Belzona Know-How System Leaflet MPT-2.
