# BELZONA PROTECTS TUNNEL AGAINST EROSION

ID: 5905

Application: VPF-Valves, Pipes and Fittings

Customer Location: Honduras

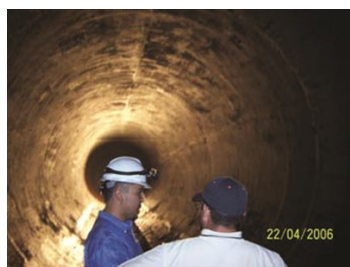
*The high flow damaged the tunnel's walls due to erosion and solutions with conventional concrete were unsuccessful in the past.*

- \* General view ,
- \* Mortar application ,
- \* Restored tunnel ,
- \* Belzona 5811 application ,
