# BELZONA ENHANCES PUMP EFFICIENCY

Application: CEP-Centrifugal Pumps

Customer Location: Water supply company, Bulgaria

Double end suction centrifugal water pump

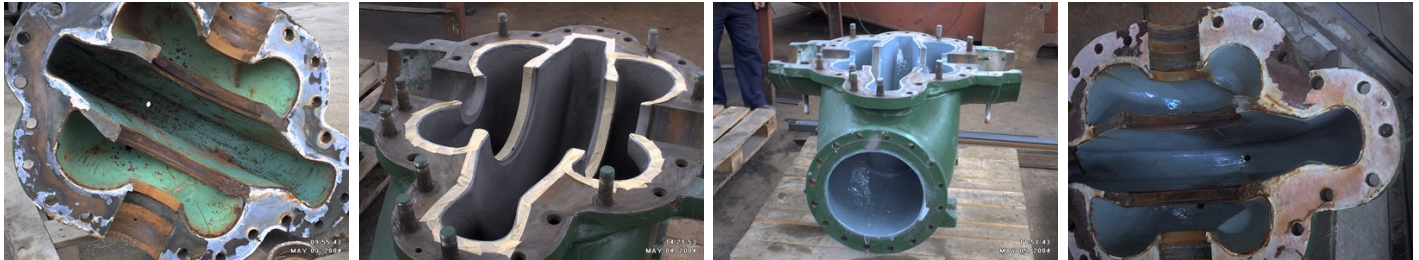
General erosion/corrosion damage leading to reduced pump efficiency

\* Surfaces before application , \* Preparation of the casing , \* Two coats of Belzona® 1341 applied , \* Inspection view after a year in service ,

Application procedures were carried out in accordance with Belzona Know-How System Leaflets CEP-5 and CEP-10.

As a result of applied efficiency enhancement coating and further sealing rings seat repair, reduced power consumption was registered and efficiency increased by 9.91%. The inspection after 12 months in service shows the perfect condition of the applied coating.
