BELZONA GIVES ABRASION RESISTANCE TO ELBOW

Application: *SHM-Solids Handling Machinery*

Worn pipe elbow

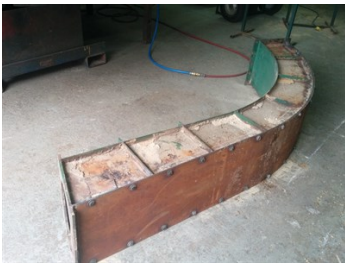
Blown wood particles create loss of wall thickness due to abrasion, eventually leading to blow-outs and loss of production.

- * General view of elbow ,
- * Application of Belzona 1812 to replaceable back ,
- * Close up of application of Belzona 1812 to elbow ,
- * Completed application ,

The application was carried out in accordance with Belzona Know-How System Leaflet SHM-8 for rebuilding worn pipe elbows. Belzona 1812 was selected as the appropriate Belzona material and applied to the wear areas of the elbow and the replaceable back, keeping within the designated wearing surface. The application was completed using a rigid applicator.
