# BELZONA EXTENDS THE LIFE OF LIME SLURRY ELBOWS

ID: 5915

Customer Location: Power Plant, Illinois, USA  
Application Date: Spring 2015

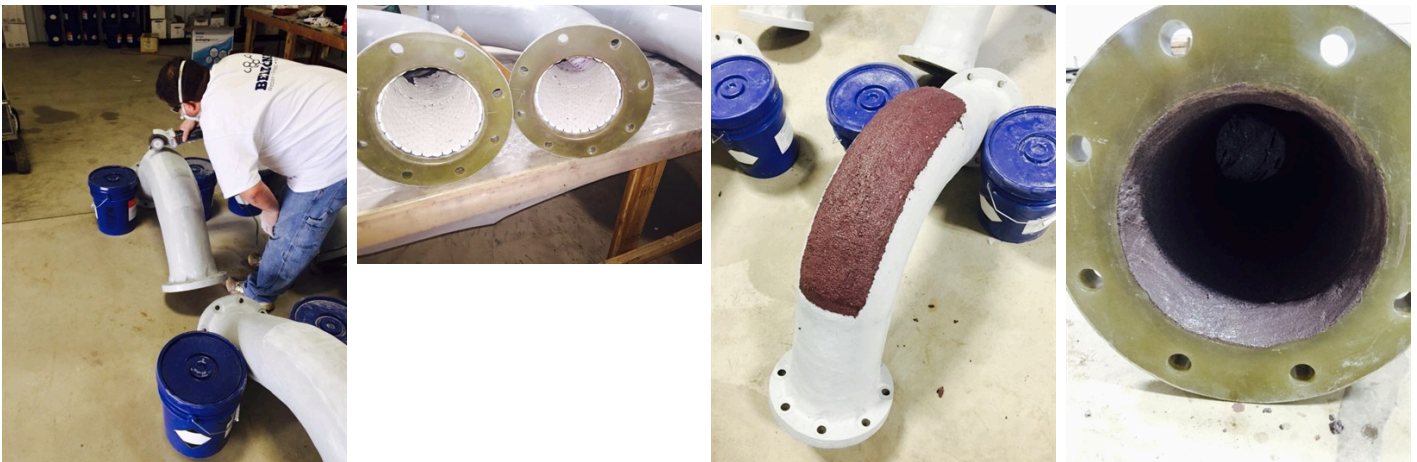
## Photograph Descriptions

FRP elbows were starting to get holes as a result from abrasion from the slurry.

- \* Surface preparation ,
- \* View of the inside and application of Belzona 9811 tiles ,
- \* Finished backing ,
- \* Belzona 1812 was sloped over and into the tile to not leave an edge for the lime slurry to get under ,

The customer had the elbow's inner diameter made 1/2" bigger to allow for the thickness of the applied Belzona products. This was done to avoid the original diameter to become enclosed, which would create a smaller area of the inner diameter and create more vortex that would result in the elbows wearing faster. The surface preparation was carried out using a MBX bristle blaster. Then, a

thin layer of Belzona 1311 was used to bond the Belzona 9811 tiles in place. Belzona 1812 was then used as a grout. The customer also asked we make a thick tiled area on the back of the elbow to see if it would result in lasting longer.
