# BELZONA PROTECTS SLUDGE PUMP

Customer Location: Wastewater treatment plant, Bulgaria

Application: CEP-Centrifugal Pumps

Casing of a sludge pump

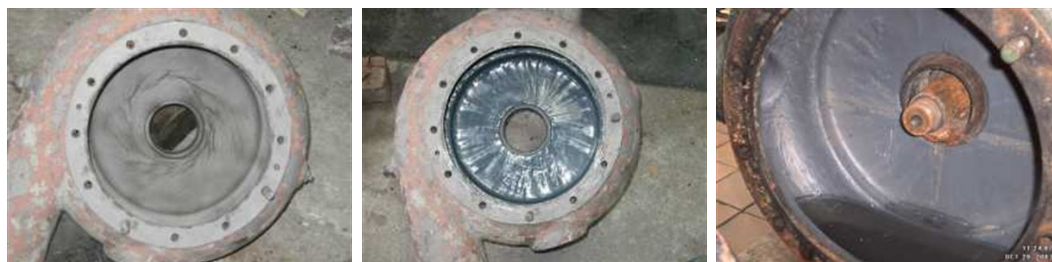
Pump casing severely eroded and corroded during operation.

\* Worn out pump casing. , \* After Belzona® 1321 application. , \* Inspection view 600 working hours after application. ,

Application procedure was carried out in accordance with Belzona Know-How System Leaflets CEP-3 & -5.

Pump suffered very low efficiency and was considered to be scrapped. Belzona was chosen both on basis of cost and fast turn-round. Inspection after 600 working hours showed the pump casing was still in excellent condition.
