BELZONA ENGINE BLOCK REPAIR SAVES BIG MONEY

Industry: *General Industry*
Application: *ENC-Engines and Casings*
Substrate: *Cast Iron*
Products: ** Belzona 1111 (Super Metal) ,*
** Belzona 9341 (Reinforcement Sheet) ,*
** Belzona 9411 (Release Agent) ,*

Customer Location: *Nashville, TN, USA*
Application Date: *September 2015*

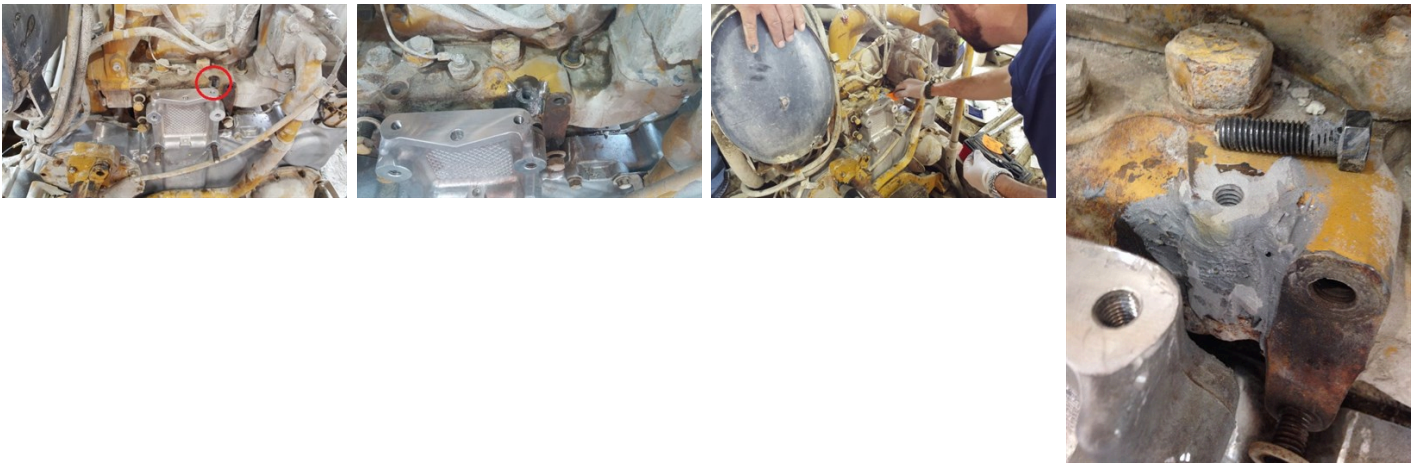
Photograph Descriptions

The engine block could not be welded on and the customer was looking for an alternative to replacing the cast block.

- * Broken bolt housing ,
- * Surface cleaned and roughened ,
- * Application in progress ,
- * Bolt removed, ready for reassembly ,

A bolt for a mounting bracket was broken out from the engine block.

The application was carried out in accordance with modified versions of Belzona Know-How System Leaflets ENC-1 & ENC-2. After cleaning and degreasing the surface, a rotary tool was used to roughen the surface. A final cleaning/degreasing was carried out. While this was occurring, two coats of Belzona 9411 were applied to the bolt, which would be used to create new threads. After Belzona 9411 dried, the threads on the block and the bolt were wetted out with Belzona 1111 and the bolt was aligned with the

remaining threads. Belzona 1111 and Belzona 9341 were used to rebuild the broken section of the block. A heat gun was used to hasten the cure time and after 4 hours the bolt was backed out and the rough edges were smoothed with a file before final reassembly.
