# BEARING HOUSING REPAIR WITH BELZONA

Industry: *Water / Wastewater*  
Application: *MPT-Mechanical Power Transmission*

Customer Location: *Watersupply company, Bulgaria*  
Application Date: *April, 2003*

Centrifugal pump bearing housing

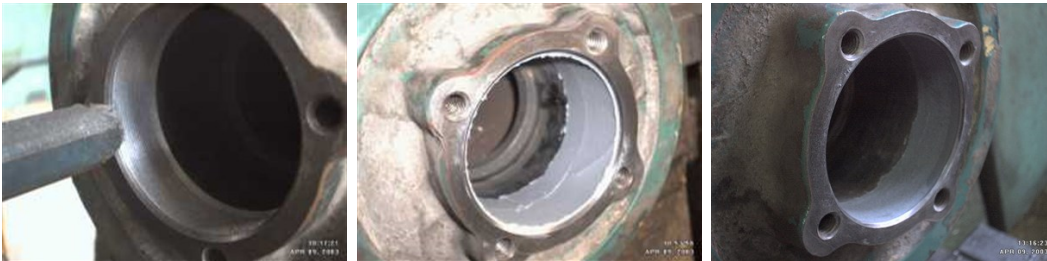
## Photograph Descriptions

*Housing damage after bearing seized leading to increased clearance.*

- \* Preparing surface ,
- \* Belzona® 1111 applied ,
- \* Housing with restored dimensions after machining ,

Application was carried out in accordance with Belzona Know-How System Leaflet MPT-6.
