BELZONA STOPS HIGH VOLTAGE CIRCUIT BREAKER LEAK

ID: 5935

Customer Location: Electricity distribution company,
Queensland, Australia

Application: VPF-Valves, Pipes and Fittings

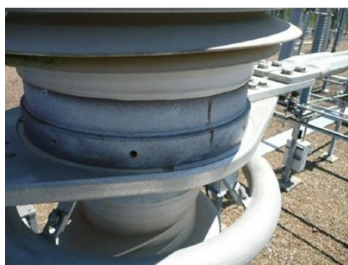
With a broken seal, SF6 gas was leaking into the environment. SF6 is potent greenhouse gas and subject to strict environmental control.

* 1. Damaged Circuit Breaker 2. Surface Preparation underway 3. Application of Belzona 1212 wrap being carried out. 4. Completed Application ,

An aging circuit breaker seal had failed.

After Bristle blasting the substrate a wrap incorporating Belzona 9341 (Reinforcement Tape) in Belzona 1212 was applied around the circumference in accordance with Belzona System Leaflet VPF-11. The repair was allowed to cure overnight before returning to service.
