# Belzona Repairs and Protects Corroded Exhibition Supports

**Customer Location:** Museum, Bristol, UK  
**Application Date:** September, 2015

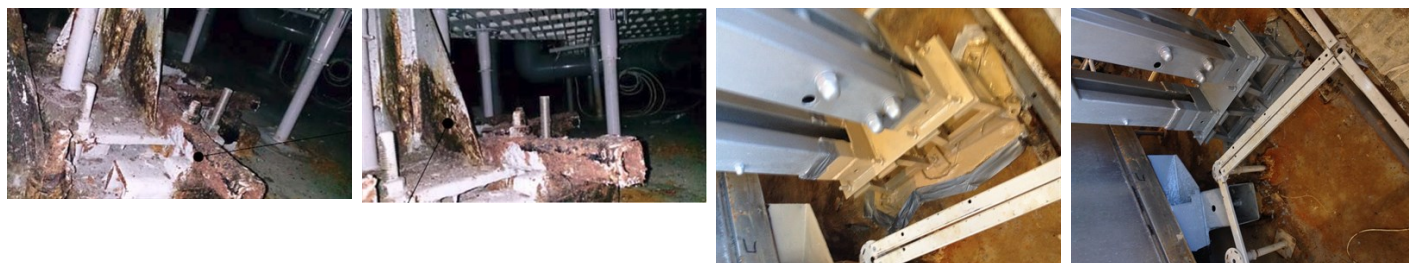
During the life of the exhibition, the metal support structure underneath the exhibition was heavily corroded by the oxidising nature of the Bromine Water. The museum were concerned about the corrosion and thus the decreasing strength of the supports.

- \* 1. Supports before application ,
- \* 2. Supports before application ,
- \* 3. Application of 5811 underway ,
- \* 4. Finished application showing close colour match achieved with Belzona 5111 ,

Application was carried out in accordance with Belzona System Leaflet TCC-5. The corroded metal structure was blasted back to bare metal using sponge blasting as the client was concerned about the dust created by using regular grit blasting. Areas that were especially corroded and damaged were rebuilt using Belzona 1111. Belzona 5811 was applied with a top coat of Belzona 5111 to protect against oxidation and provide a good colour match.
