BELZONA TIRE REPAIR QUICKLY GETS LOADER BACK IN SERVICE

ID: 5937

Repair of the tire sidewall on a front end loader.

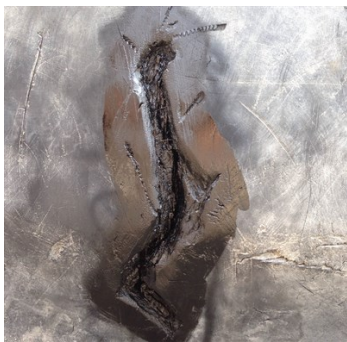
- * Crack cleaned, roughened, and conditioned. ,
- * Application of Belzona 2311. ,
- * Two weeks later, material which had exceeded the conditioned area had peeled and need to be trimmed off (always tape off your edges!). ,
- * Repair revisited 3 Months after application, Belzona still perfectly adhered. ,

The application was carried out in accordance with Belzona Know-How System Leaflet SHM-15. The area to be treated was cleaned with a cleaner/degreaser and then abraded using a wire wheel, Belzona roughing brush and rotary tool. After a final cleaning the area was treated with Belzona 2911 and allowed to dry for 30 minutes. Belzona 2311 was then used to coat the radials and rebuild
