# BELZONA REPAIR EXTENDS SERVICE LIFE OF TIRE

ID: 5938

Industry: Mining & Quarrying  
Application: SHM-Solids Handling Machinery

Customer Location: Quarry, Tennessee, USA  
Application Date: September 2015

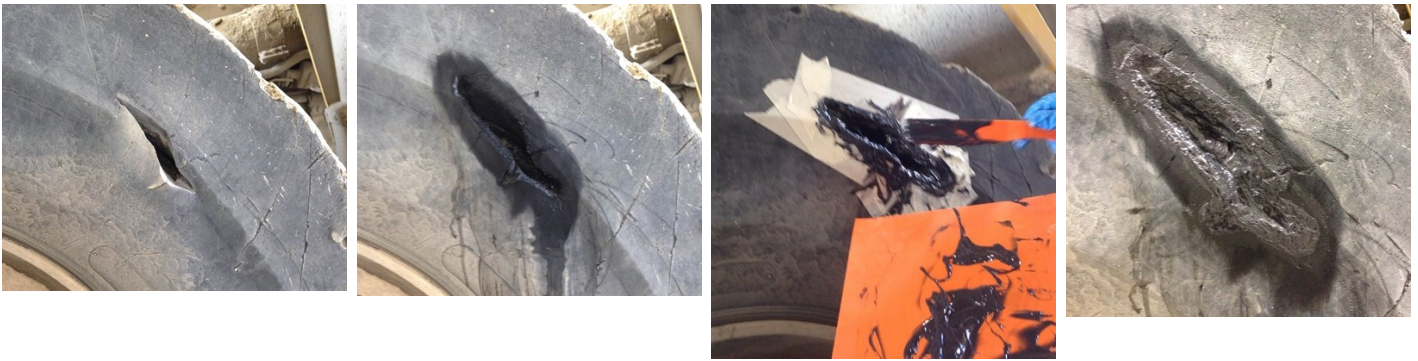
A large crack had developed in the tire sidewall, over 8 inches long and more than 3 inches deep in places. The "half-track" tire (outer half solid rubber/inner half inflated) was nearing the end of its service life and the customer had ordered a new one but had already been waiting for over two months. The site superintendent was very concerned that the crack would continue to grow and reach a point of being unsafe before new tires became available.

- \* Large crack in tire ,
- \* Crack being terminated, cleaned, roughened and conditioned ,
- \* Application of Belzona 2311 in progress ,
- \* Completed application ,

Large split in the tire (Half Track) sidewall.

The application was carried out in accordance with Belzona Know-How System Leaflet SHM-15. The ends of the crack were rounded out and terminated and the substrate was well cleaned and degreased before roughening with a Belzona roughing brush and rotary tool. The surface was then cleaned a second time, edges were taped off, and the substrate was conditioned with Belzona 2911 and allowed to dry for 30 minutes. After the conditioner had dried, two units of Belzona 2311 were used to fill the crack and rebuild the

surface profile of the tire.
