Belzona Renews Black Water Tank

ID: 595

Industry: *Marine*
Application: *SOS-Ships and Offshore Structures*

Black water tank in 80 ft Aluminum motor yacht.

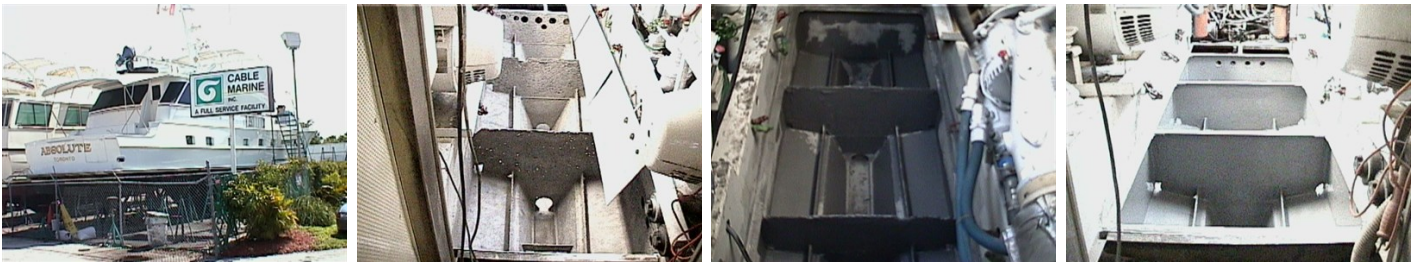
Photograph Descriptions

Severe pitting caused by H2S attack of aluminum walls, top and supports causing leakage of sewage to bilge.

- * My Absolute at Cable Marine, Ft. Lauderdale, Florida ,
- * Severe pitting wastage of tank walls and supports ,
- * Doubler plates and Belzona® 1121 applied ,
- * Final protection with Belzona® 5811 awaiting top ,

Application was carried out in accordance with Belzona Know-How System Leaflet SOS-5. Doubler plates bonded to 4 sides and supports faired with Belzona® 1121. All surfaces coated with Belzona® 5811.
