Belzona Renews Black Water Tank

ID: 595

Black water tank in 80 ft Aluminum motor yacht.

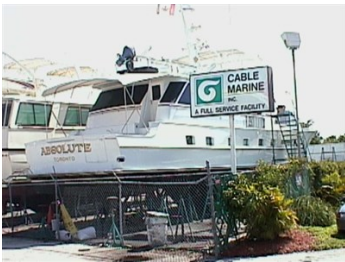
Severe pitting caused by H₂S attack of aluminum walls, top and supports causing leakage of sewage to bilge.

- * My Absolute at Cable Marine, Ft. Lauderdale, Florida ,
- * Severe pitting wastage of tank walls and supports ,
- * Doubler plates and Belzona® 1121 applied ,
- * Final protection with Belzona® 5811 awaiting top ,

Application was carried out in accordance with Belzona Know-How System Leaflet SOS-5. Doubler plates bonded to 4 sides and supports faired with Belzona® 1121. All surfaces coated with Belzona® 5811.
